Madrid
13-15 October 2014

Paper Ref 134

Pipe Grouting Longevity Effectiveness Evaluation

James W. Shelton, PE, ARCADIS, King of Prussia, PA

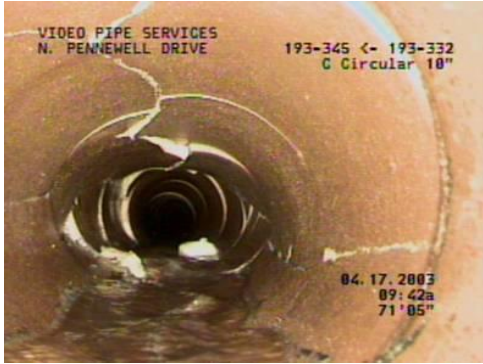
Figure 1
Structurally Compromised Pipe

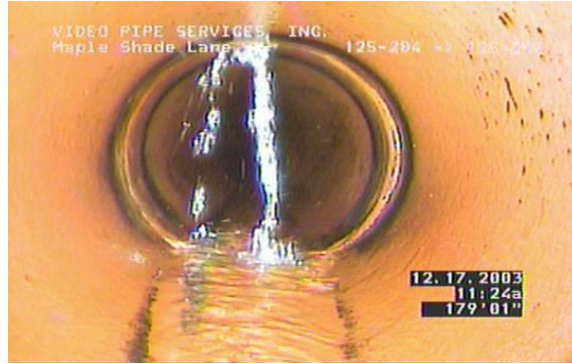
Figure 2
Structurally Sound, but Leaking Joint

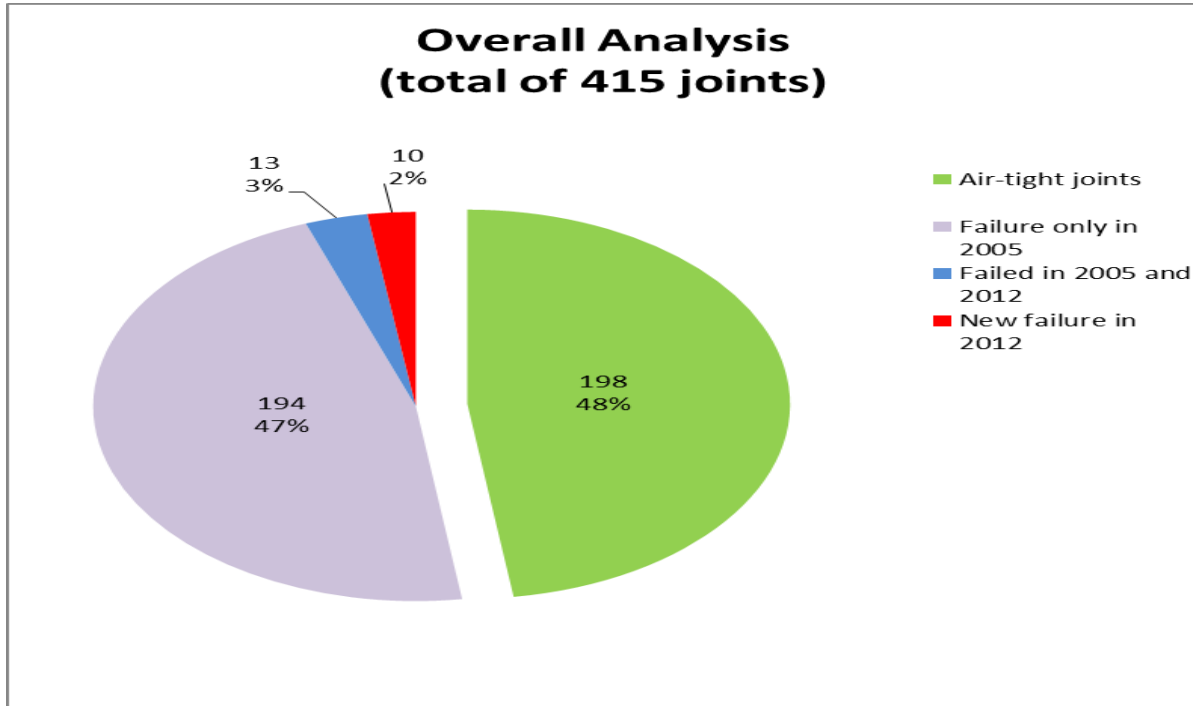
Of the 415 joints originally tested, 207 (50%) had failed in the original test and seal projects. These joints received an average of 4.3 gallons of grout under the initial rehabilitation project. Upon retesting these 207 joints, 13 (6%) were found to again fail. These 13 joints required an average of 4.6 gallons of additional grout to reseal. With an

average of nearly 9 gallons of grout pumped per mainline joint, clearly there are significant bedding voids near these 13 particular joints.

Of the 208 (50%) that had passed the air test originally, on 10 (4%) were found to fail. In total, after 7 years, less than 5% of all the mainline joints were found to have failed. These new failures required an average of 4.8 gallons of grout to seal.

Figure 5: Mainline Joint Test Results

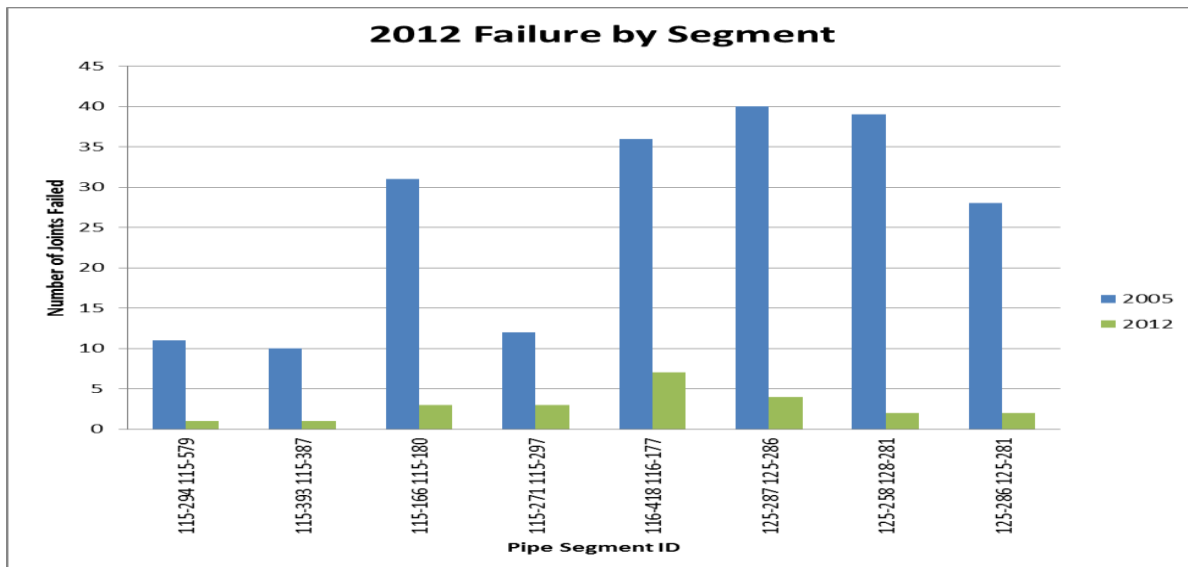
Figure 6: Segment Mainline Joint Test Results

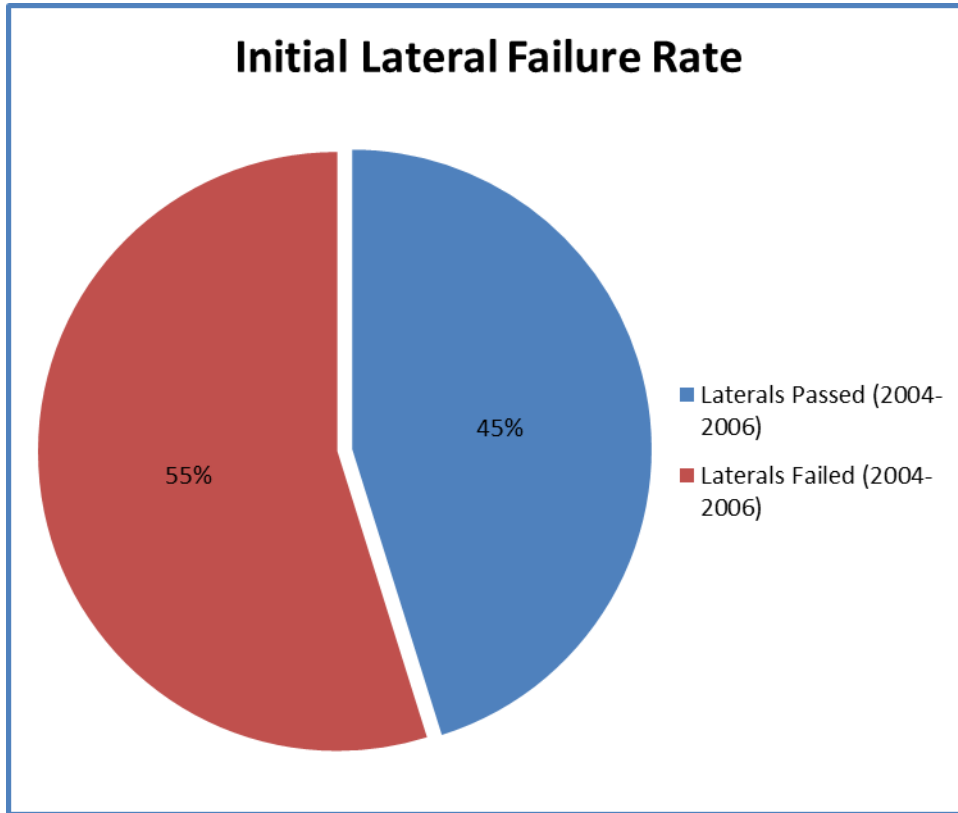
Seven segments containing 31 lateral taps were selected to be air pressure tested and, if found to fail the test, be grouted (or regrouted, as the case might be). These 31 lateral taps were purposefully selected because of their high rate of failure during the initial rehabilitation. Of the 31 lateral taps originally tested, 17 (55%) had failed in the original test and seal projects. These joints received an average of 4.2 gallons of grout under the initial rehabilitation project.

Figure 7: Lateral Tap Test Results

Upon retesting 7-9 years later, none of these taps failed the air test.
