North American Society for Trenchless Technology (NASTT)
NASTT's 2016 No-Dig Show

Paper: MA-T1-03

**Injection Grouts and CIPP Lining Revitalize Buried Assets on
Treasure Island**

Michael Helfrich, City of Treasure Island, Treasure Island, FL, USA
Joyce T. Velitschkowski, J.T.V., Inc. (J.T.V.), St. Petersburg, FL, USA
Don Rigby, Avanti International, Houston, TX, USA

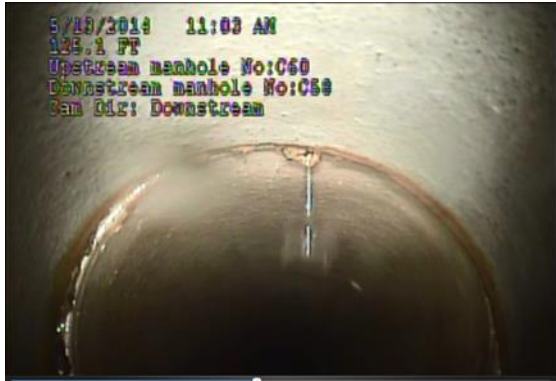
Figure 5. Gravity Sewer Line with Constant Drip from Infiltration

The condition of the clay (Terracotta) pipe was cracked, allowing a large amount of groundwater to infiltrate as illustrated in Figures 5 and 6. The result of the video surveillance allowed us to identify the two areas shown in Figure 7 as the main culprits of infiltration.

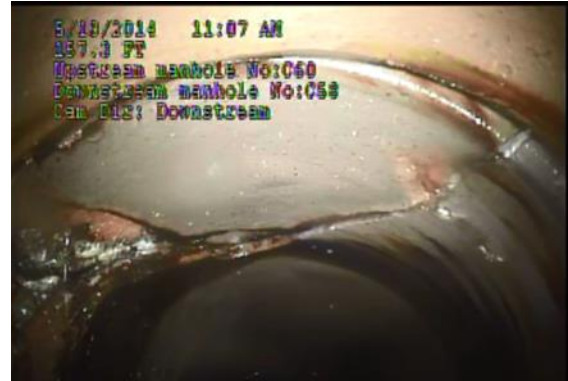
Figure 6. Typical Gravity Sewer Line Damage with Infiltration

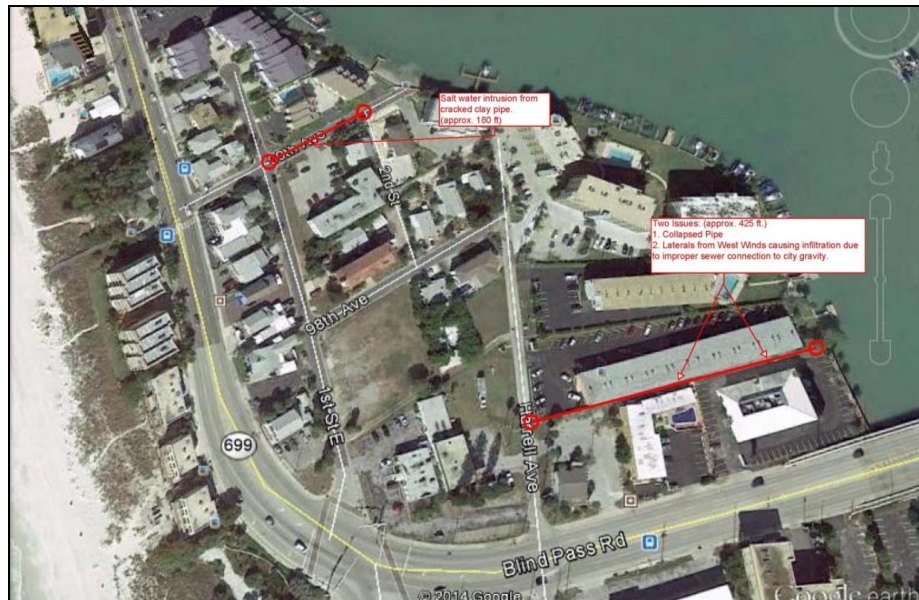
Figure 7. LS #3 Area with Extreme Infiltration

J.T.V. was contracted by the City of Treasure Island to rehabilitate the 8-inch diameter by 436 linear feet of vitrified clay pipe (VCP) sanitary sewer line. Within the scope of services was heavy cleaning to remove mineral deposits, removal of protruding service connections, pipe joint air test and seal, CIPP lining of the sanitary sewer main, nine lateral reinstatements, and lateral grouting.

Heavy mineral deposits were accumulated at each of the leaking joints and fractures. J.T.V. utilized robotic cutters to mill the mineral deposits from the VCP to minimize any additional damage to the pipe. Lining material was installed to an 8-inch diameter and 7.5 mm finish due to the shallow elevation of the pipe and overall longevity of the final product. Lateral grouting also required a higher than normal quantity of grout due to the existing voids from years of infiltration. Manhole 56 was an outside drop manhole, and it was determined that the last joint of the drop was severely separated allowing approximately 30 gallons per minute of groundwater to infiltrate into the system. J.T.V. plugged the bottom of the drop, pumped AV-100 into the drop, and sealed the section of pipe. The CIPP liner was extended into the manhole and a PVC inside drop was constructed to replace the defective drop. The finished product achieved a 91% reduction in chlorides and a 30% reduction in flow.
