**North American Society for Trenchless Technology (NASTT)
NASTT's 2014 No-Dig Show**

TM2-T4-04

Pipe Grouting Longevity Effectiveness Evaluation

James W. Shelton, PE, ARCADIS, King of Prussia, PA

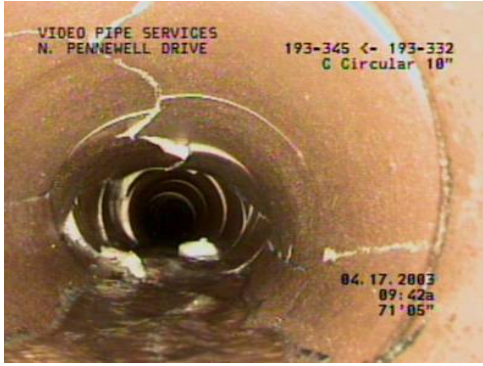
Figure 1
Structurally Compromised Pipe

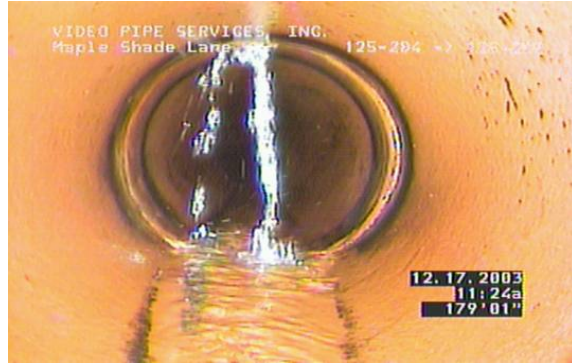
Figure 2
Structurally Sound, but Leaking Joint

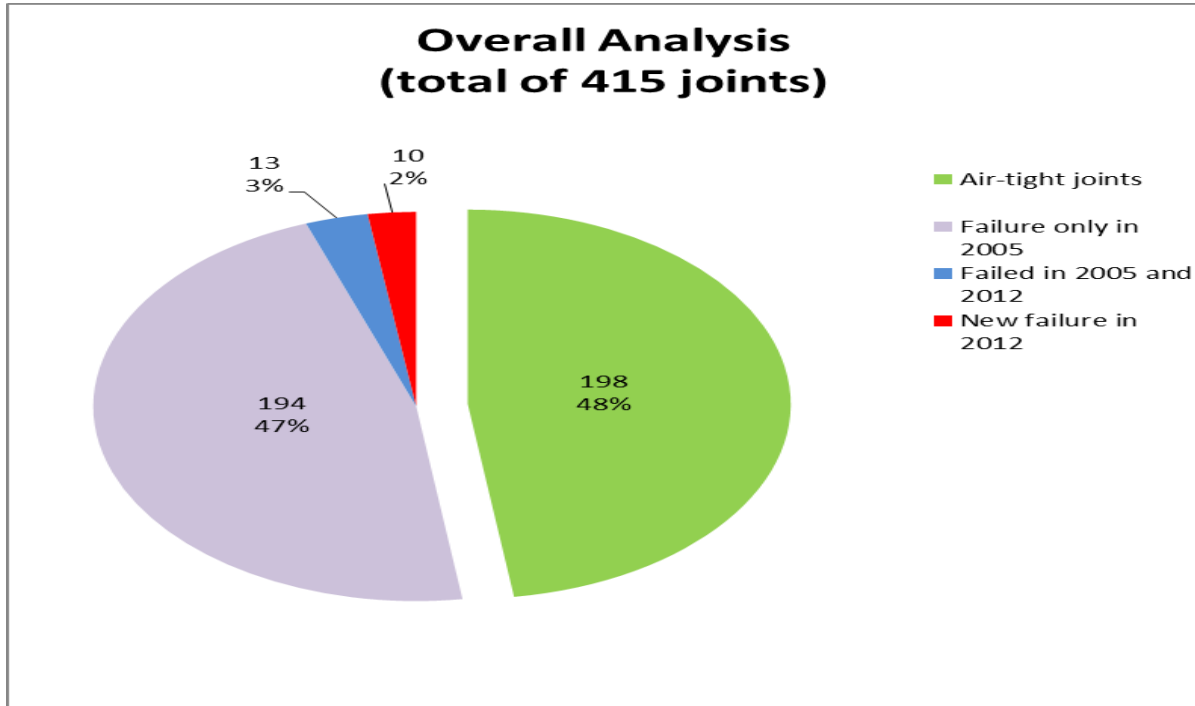
Figure 5: Mainline Joint Test Results

Of the 415 joints originally tested, 207 (50%) had failed in the original test and seal projects. These joints received an average of 4.3 gallons of grout under the initial rehabilitation project. Upon retesting these 207 joints, 13 (6%) were found to again fail. These 13 joints required an average of 4.6 gallons of additional grout to reseal. With an

average of nearly 9 gallons of grout pumped per mainline joint, clearly there are significant bedding voids near these 13 particular joints.

Of the 208 (50%) that had passed the air test originally, on 10 (4%) were found to fail. In total, after 7 years, less than 5% of all the mainline joints were found to have failed. These new failures required an average of 4.8 gallons of grout to seal.

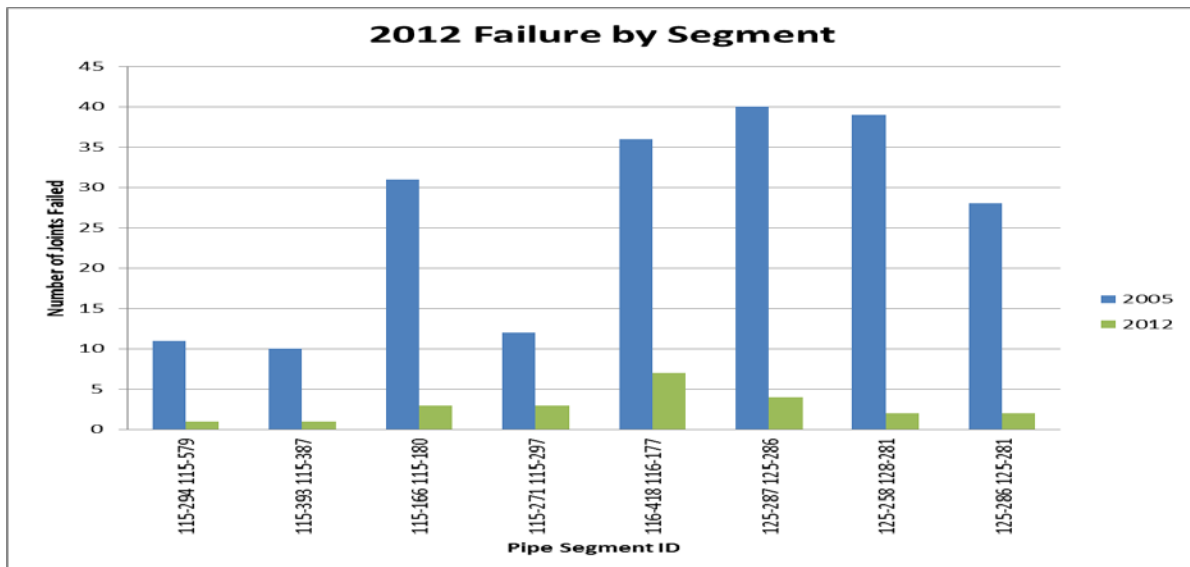
Figure 6: Segment Mainline Joint Test Results

A segment by segment presentation of these data is presented below.

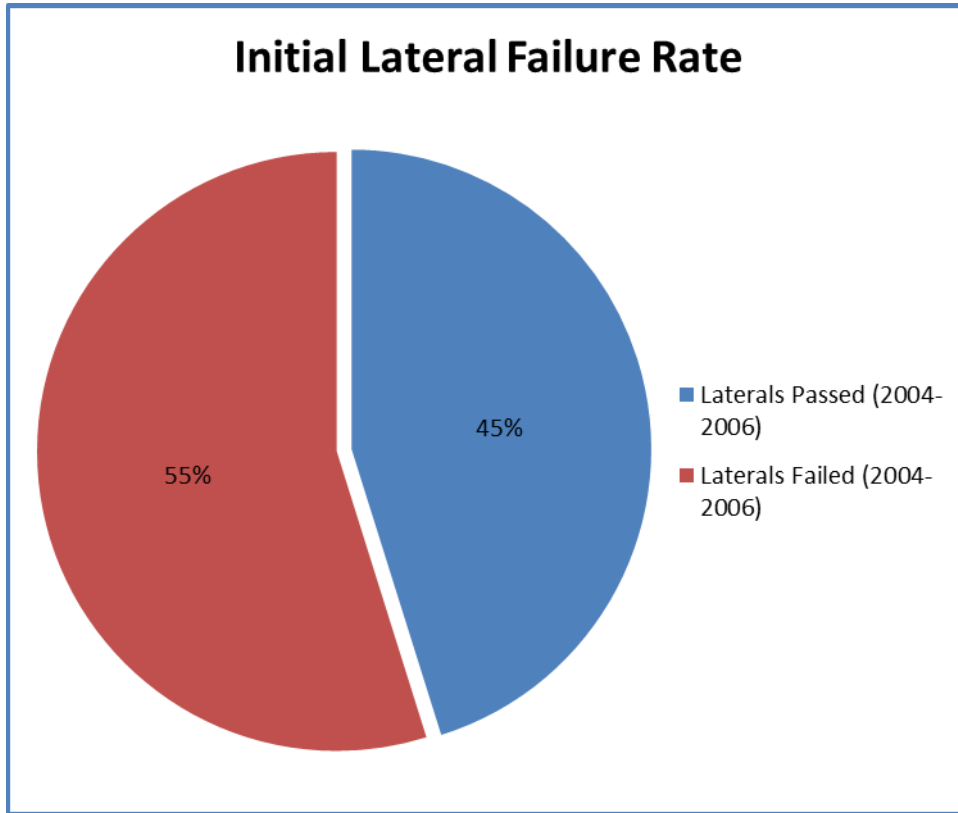
Figure 7: Lateral Tap Test Results

Seven segments containing 31 lateral taps were selected to be air pressure tested and, if found to fail the test, be grouted (or regrouted, as the case might be). These 31 lateral taps were purposefully selected because of their high rate of failure during the initial rehabilitation. Of the 31 lateral taps originally tested, 17 (55%) had failed in the original test and seal projects. These joints received an average of 4.2 gallons of grout under the initial rehabilitation project.

Upon retesting 7-9 years later, none of these taps failed the air test.
