Grouting Saves Effluent Pipeline and Maintains Plant Operations

By Dick Berry
Rembco Engineering

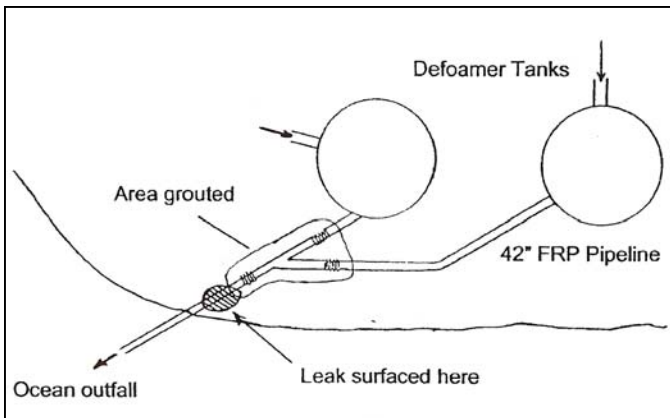
The leak was in an area where two individual pipes came from defoaming tanks joining in a "Y" to a single line before discharge.
