Grouting Saves Effluent Pipeline and Maintains Plant Operations

By Dick Berry
Rembco Engineering

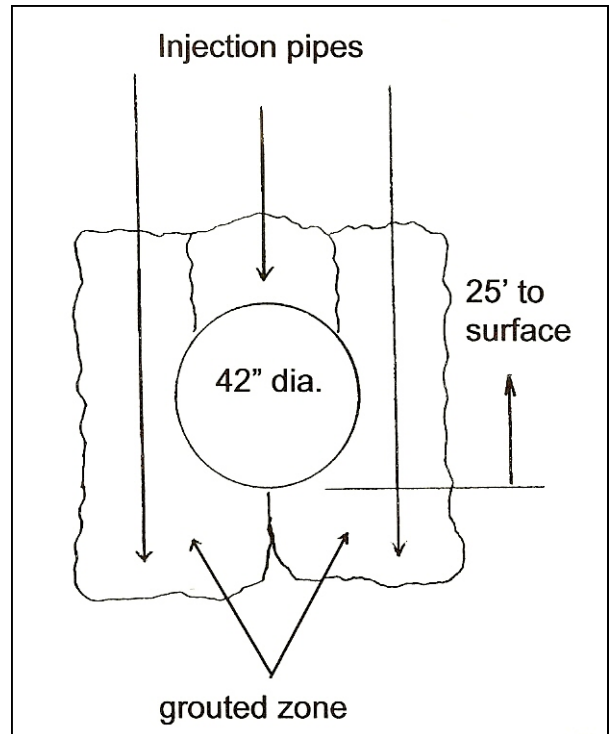
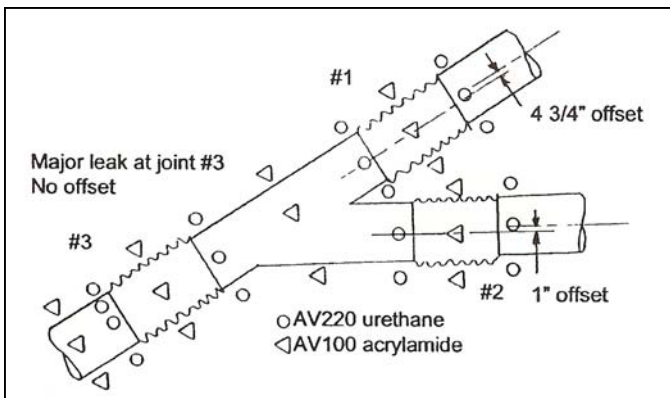
The leak was in an area where two individual pipes came from defoaming tanks joining in a "Y" to a single line before discharge.

670 cubic feet of bedding. After the first grouting with AV-220, leakage during pipeline use periods began to slow, reaching about 20 gpm as a low point.

A total of 2,375 gallons of AV-100 (acrylamide) was then injected through 15 grout pipes, filling another calculated 700 cubic feet of bedding. During this secondary grouting, all flow back to the surface stopped. To the surprise and delight of all, the leak was completely stopped by grouting from the outside of a large pressure pipeline operating at an internal pressure of about 18 psi. Grouting with AV-100 was continued until there was nowhere else in the immediate area to get any more grout into the ground.
